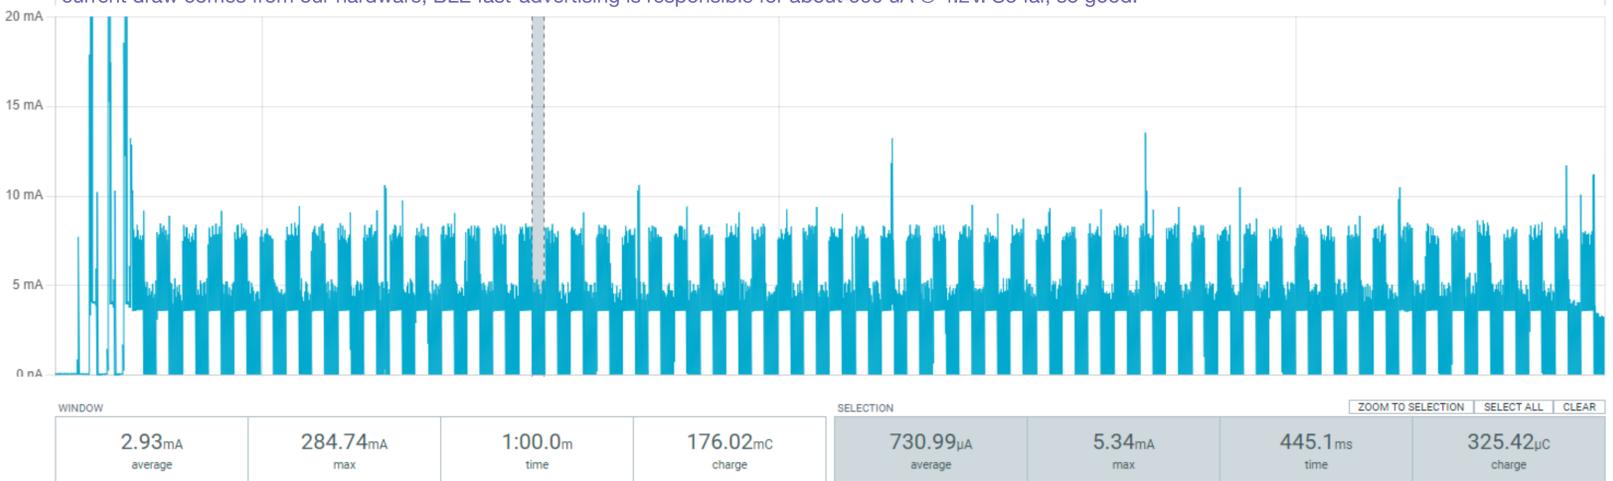
1) This is what our system looks like when we're BLE fast-advertising. The square-wave pattern is due to the fact that we are blinking an LED on-and-off every second in this mode. The selection shown is during a period when the LED is off and we have no threads running, so the nRF52840 is in Sleep. Since approximately 70 uA of current draw comes from our hardware, BLE fast-advertising is responsible for about 660 uA @ 4.2V. So far, so good.

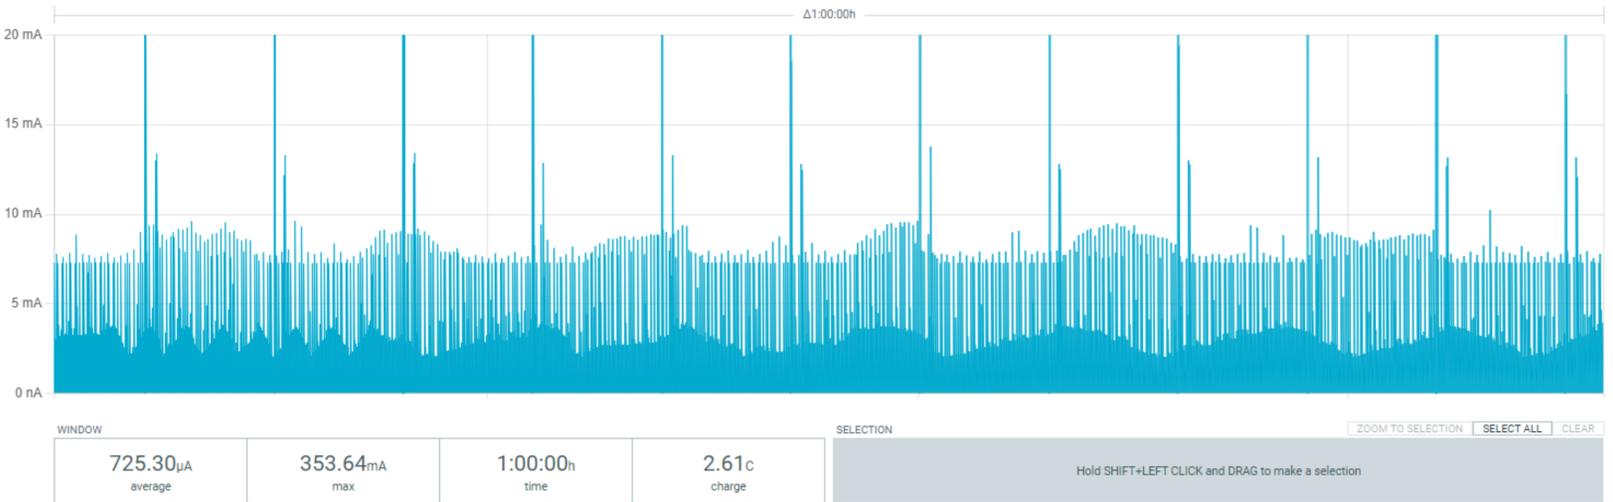
2) This is the view of our system over 1 hour representing what we're seeing typically seeing during the first 6 hours after connecting our device to the iPhone over BLE, whether or not the iPhone is actively being used or is sleeping. The big spikes are periodic measurements every 5 minutes, the forest of spikes up to around 8 mA are our threads briefly running. But what we're focusing on is the solid area at the bottom, which represents BLE current draw; as shown in the next zoomed image, this BLE current draw isn't really solid, and is responsible for about 180 uA on average. This still all good and what we'd expect to see all the time.

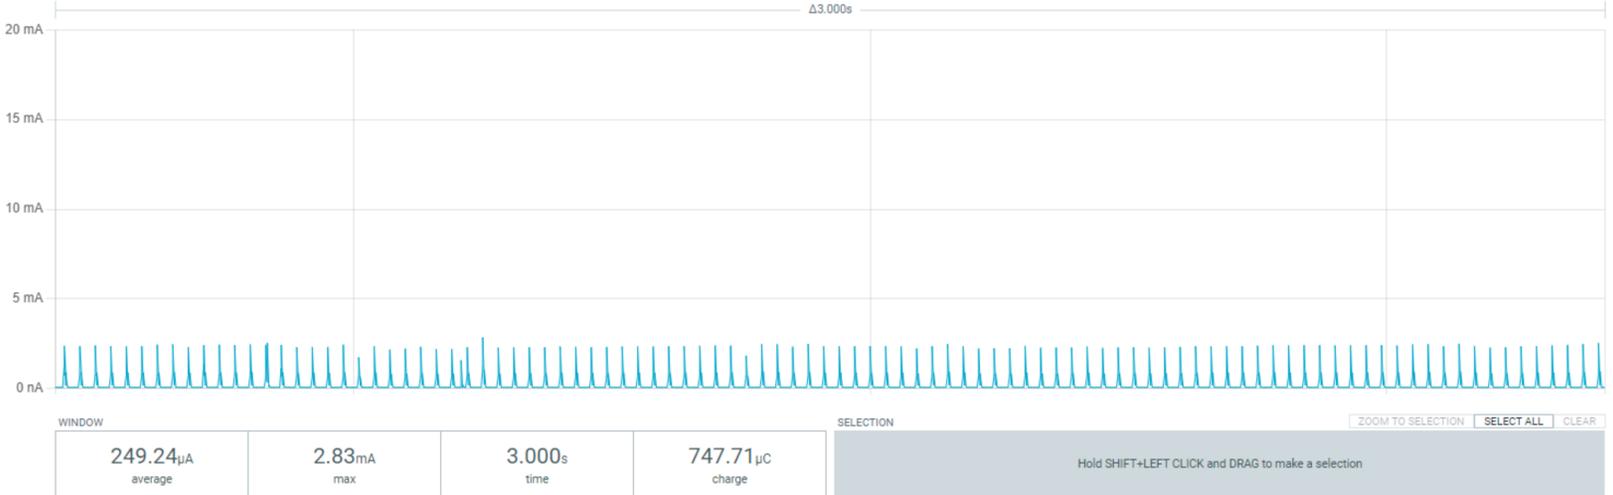
3) Here we've zoomed-in on a 3-second section of the above image showing the current draw due to BLE in the first six-hours after connecting the device to the iPhone over BLE. This is a section without any of our threads running, so the nRF52840 is in Sleep mode. Our hardware is responsible for about 70 uA of this, so roughly 180 uA are due to BLE being connected in this mode. Looks good.

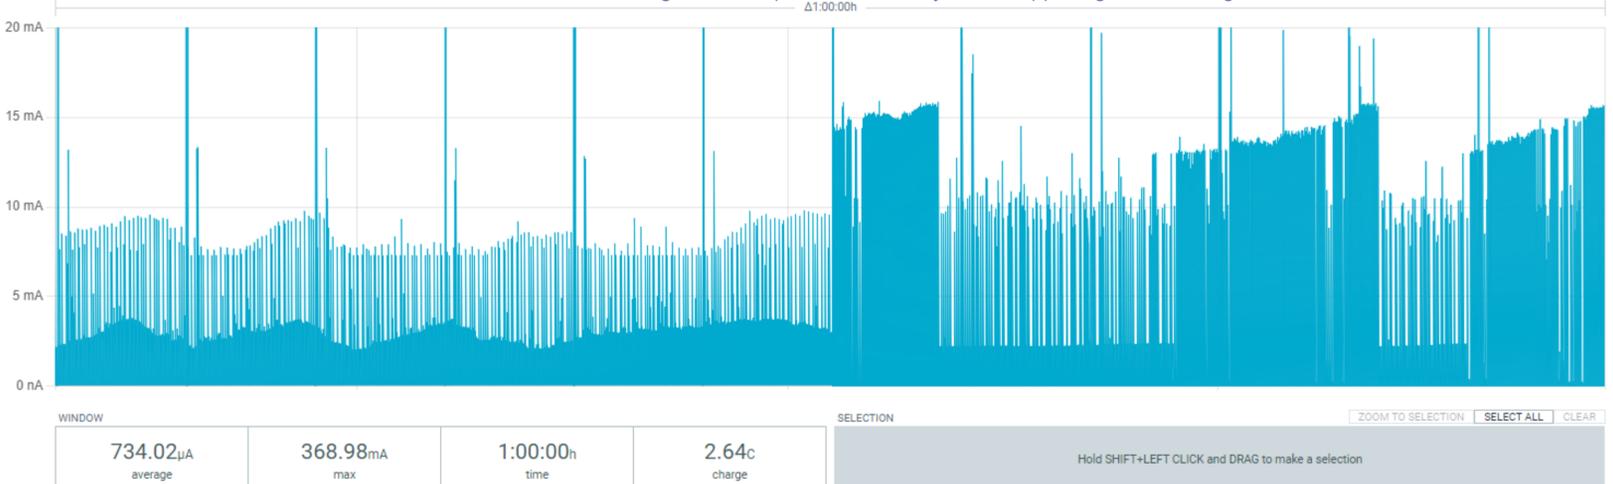
4) Here's where the problem we're investigating starts, 6 hours and 20 minutes after connection to the iPhone. This occurred in the middle of the night, no with interaction with the iPhone or change to the test configuration. As shown, starting around the the middle of the image, the nature of the BLE current draw on the system changes dramatically. We start getting these long upsweeping runs of high current draw from BLE that occur over roughly a ten-minute period, interspersed with minutes of normal BLE current draw. Details on the next image, but our questions are, Why is this happening? What changed?

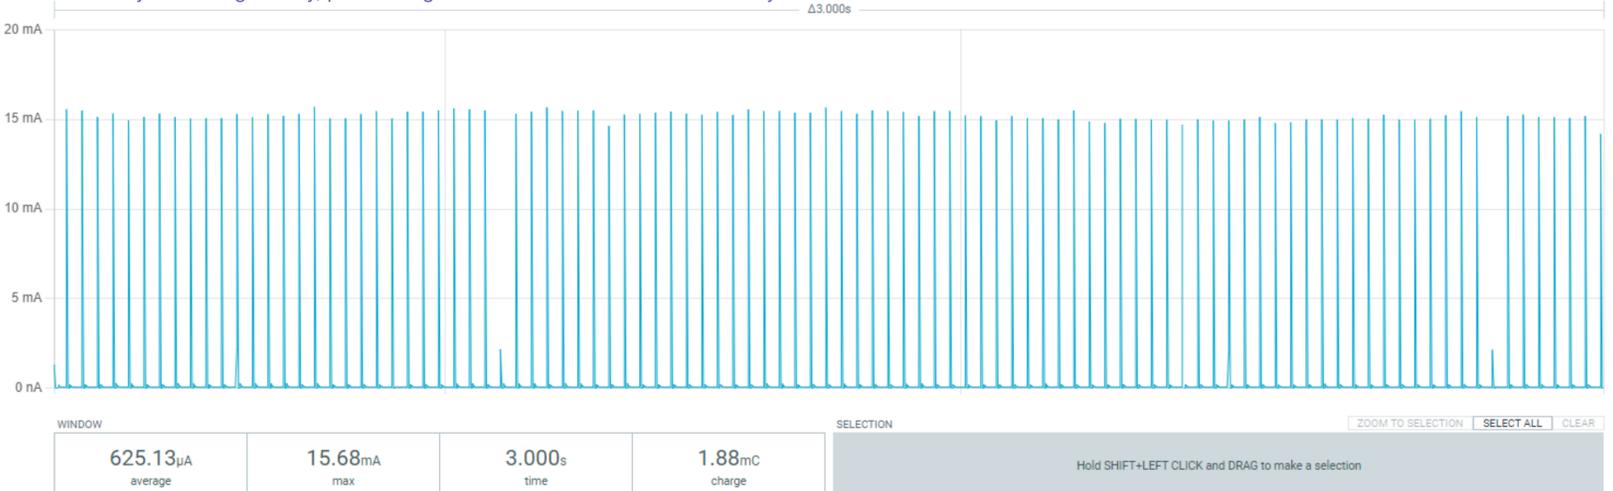
5) Here we've zoomed-in on a 3-second section of the above image showing one of the high-current-draw areas due to BLE. Again, this is a section without any of our threads running, so the nRF52840 is in Sleep mode. Our hardware is responsible for about 70 uA of this, so we're seeing a jump in BLE current draw from roughly 180 uA before the problem starts, to about 550 uA here. We can tell that none of our threads are running this section, so this is not a case where our mobile app is suddenly increasing activity, plus the high current draw is consistent for many minutes at a time.

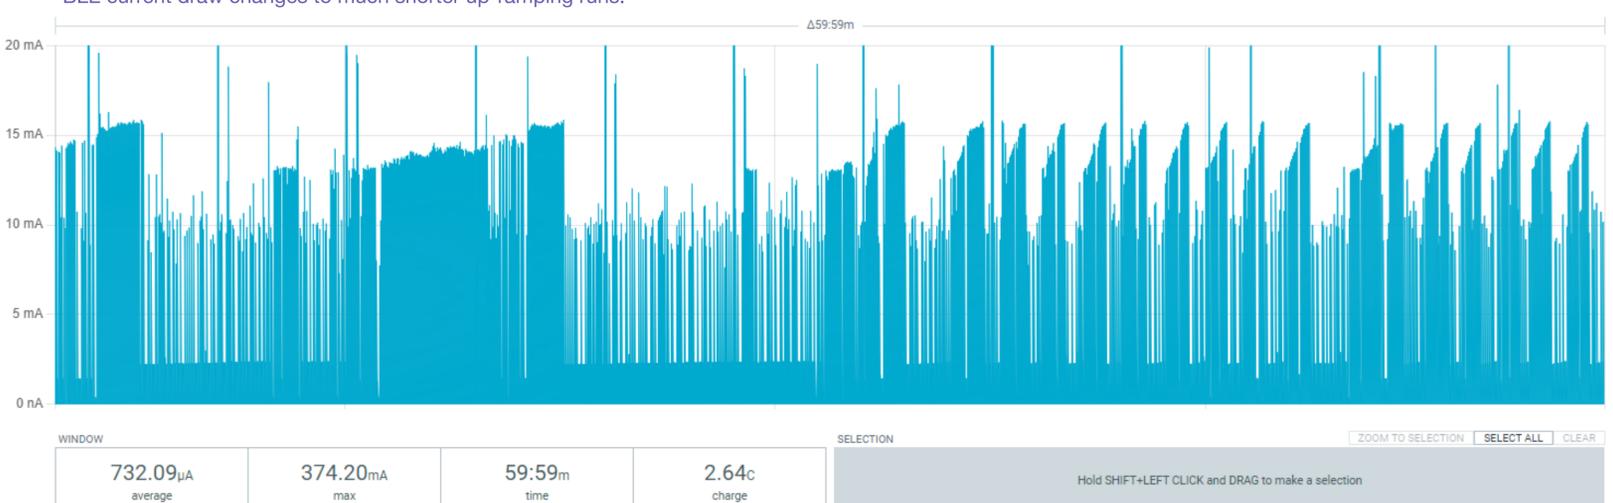
6) Our best hypothesis so far is that the change in current draw shown above may be due to some interaction between the iPhone and the S113 SoftDevice, perhaps long periods of inactivity on the phone. While the problem started occurring about 6:20 hours after connection, it was probably between 5:45 - 6 hours after the iPhone went to sleep. This made us curious if the problem would disappear once the iPhone (but not our mobile app) started being interacted with the next morning, which occurred around the middle of the image below. Interestingly, we're still getting the high BLE current draw, but we do see a change in behavior: the pattern of BLE current draw changes to much shorter up-ramping runs.
