BL652 Firmware Upgrade attempt using Segger Jlink Edu 4 January 2017

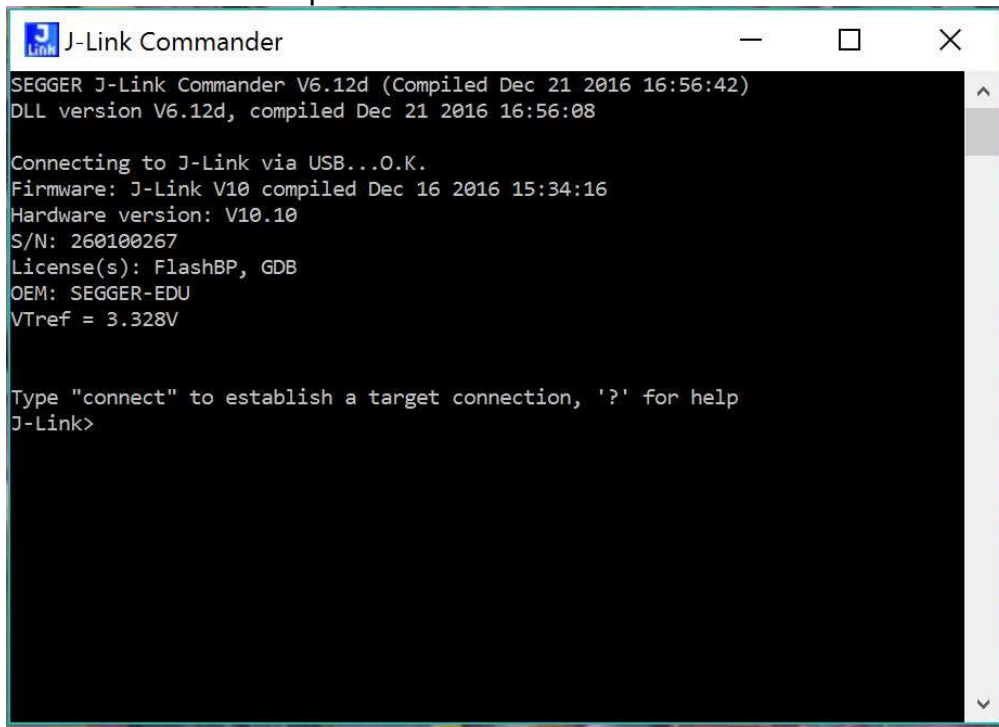
JLink Commander capture

```
J-Link Commander
SEGGGER J-Link Commander V6.12d (Compiled Dec 21 2016 16:56:42)
DLL version V6.12d, compiled Dec 21 2016 16:56:08

Connecting to J-Link via USB...O.K.
Firmware: J-Link V10 compiled Dec 16 2016 15:34:16
Hardware version: V10.10
S/N: 260100267
License(s): FlashBP, GDB
OEM: SEGGER-EDU
VTref = 3.328V

Type "connect" to establish a target connection, '?' for help
J-Link>
```

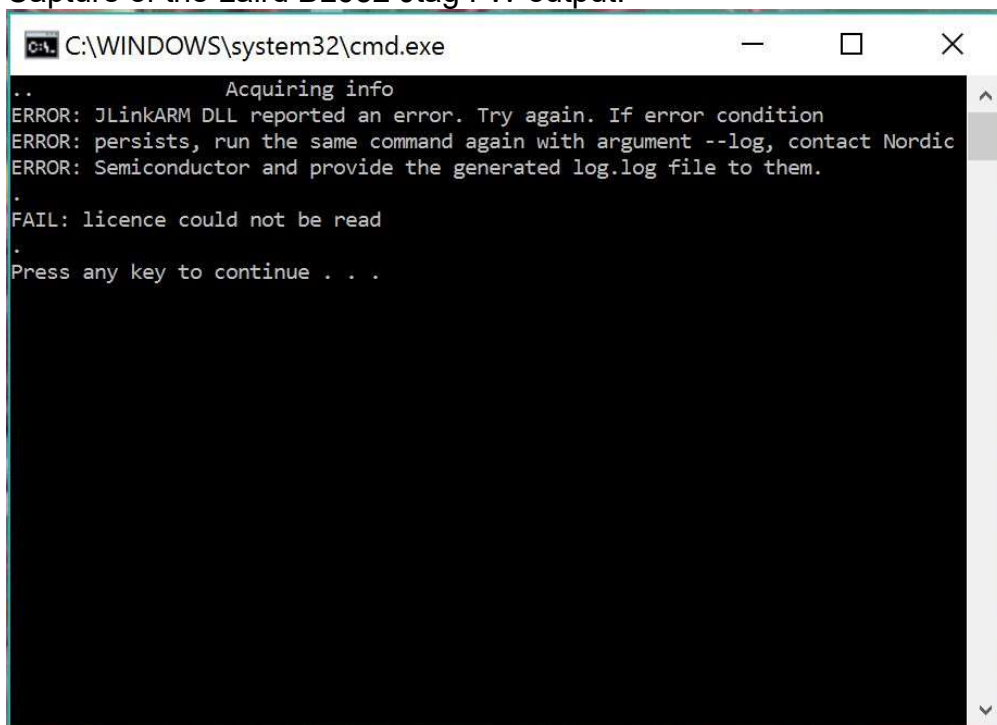
Capture of the Laird BL652 Jtag FW output.

```
C:\WINDOWS\system32\cmd.exe
..      Acquiring info
ERROR: JLinkARM DLL reported an error. Try again. If error condition
ERROR: persists, run the same command again with argument --log, contact Nordic
ERROR: Semiconductor and provide the generated log.log file to them.
.
FAIL: licence could not be read
.
Press any key to continue . . .
```
